Technical Service Bulletin

It has come to our attention that there is an installer issue when replacing our later model Freightliner Cascadia and Coronado radiators.

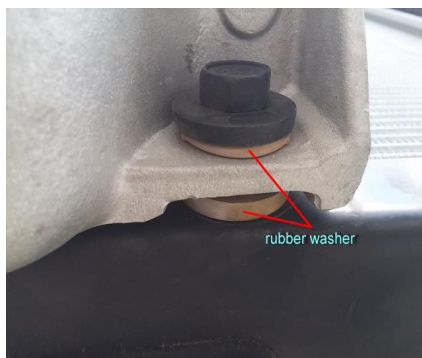
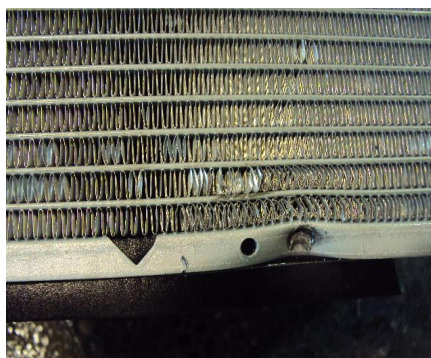
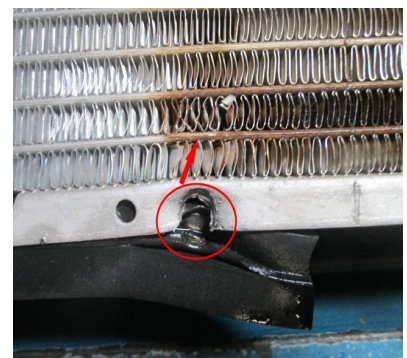
In most cases, the CAC has three mounting bolts the same length and one longer bolt with rubber spacers (see the picture included).

The Surge Tank has one bolt that mounts through the radiator frame and has a spacer that needs to be used.

Failure to carefully install the bolts/washers/spacers properly, can cause the bolt to go through the frame and damage the side plate on the radiator. This places stress on the adjacent tube and will result in the tube failing. Please see pictures below.

It is **imperative** the correct length bolts be used when mounting the charge air cooler, rock guard (if equipped) and surge tank.
